Re: Hudson River Valley Resort
DEC Tracking number 3-5146-00063/00007

RE: Williams Lake HRVR Hydrogeologic Characterization Flaws

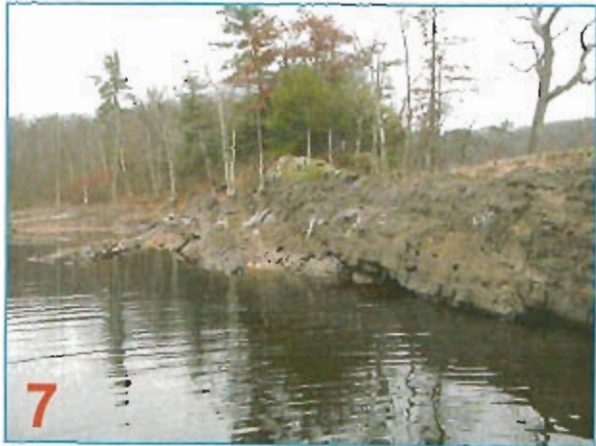
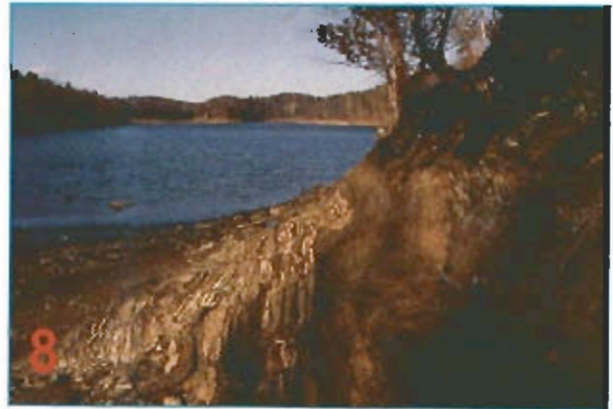
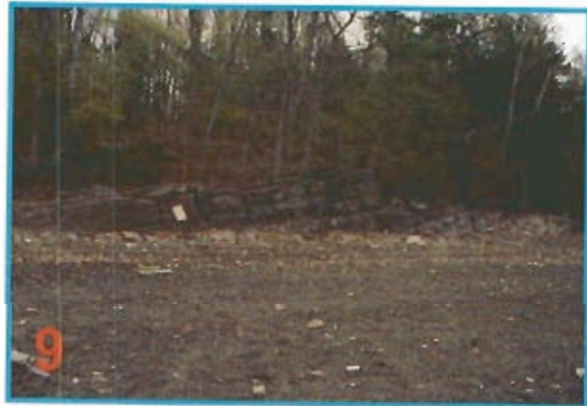
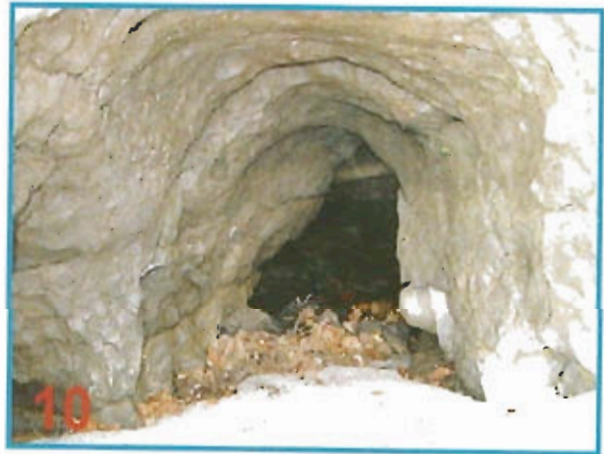
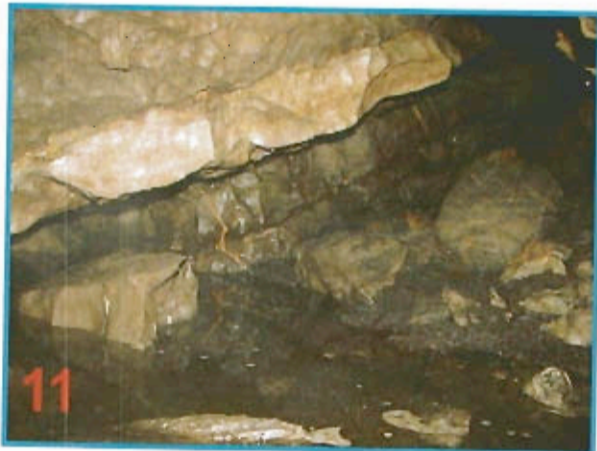
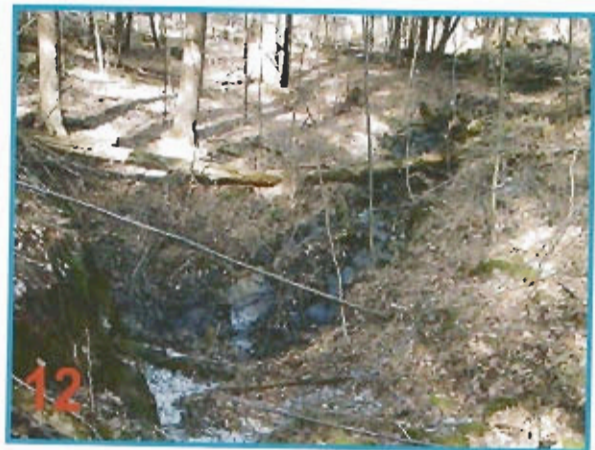
HydroQuest Photocomposite 2

- Relative to disappearing streams, such as a Cocksackie example found in the same carbonate beds as those present on the HRVR site and referred to by Dr. Ewers, HRVR states that “*No such karst related features have been found on the HRVR site.*” The loss of substantial quantities of water from Fourth Lake (i.e., a **disappearing lake**) provides irrefutable evidence of the karstic nature of the Williams Lake property. Recognition that runoff from throughout the Fourth Lake watershed enters subsurface solution conduits in carbonate bedrock is obvious. HydroQuest photos 6 and 7 show the level of Fourth Lake down approximately 10 feet. Photos 8 and 9, taken by Burmeister on October 26, 2003, depict the lake level down approximately 20 to 25 feet below flood level. Natural annual lake evaporation in the northeastern US, absent groundwater flux, is on the order of 10 to 20 inches (US Dept. of Commerce). Therefore, the loss of up to 20 plus feet of water from the surface of Fourth Lake in dry years provides solid documentation of subsurface flow loss via karstic solution conduits. It is highly likely that these conduits are within the Coeymans and Manlius limestones. **The daily loss of Fourth Lake water through karstic solution conduits is in the millions of gallons per day.** This high volume of rapid groundwater flow requires open solution conduit pathways. Clearly, HRVR’s statements that “*such voids are inhibited by thinner bedding, deformation and faulting*” are erroneous. The karstic nature of the Williams Lake area is obvious to local residents who have observed low Fourth Lake levels for years and in the dramatic seasonal lake level declines. The HRVR hydrogeologic report needs to address the actual operating karst hydrogeology, confirm where this water goes via tracer tests, and

- HRVR and the public have previously seen photographs of a natural cave that is present near the southeastern terminus of Fourth Lake (Photos 10 and 11). Solutional pock marks or scallops on the walls of this cave provide further evidence of aggressive, turbulent, flow into this cave to an undocumented down gradient location. Tracer testing is required to determine where this water and the groundwater below the nearby planned housing development goes. The chemical plots provided by HRVR cannot be used to assess groundwater pathways and down gradient receptors. The hydrogeologic study needs to assess the site's karstic and non-karstic hydrogeology. This assessment should be conducted prior to issuance of a DEIS for public review.

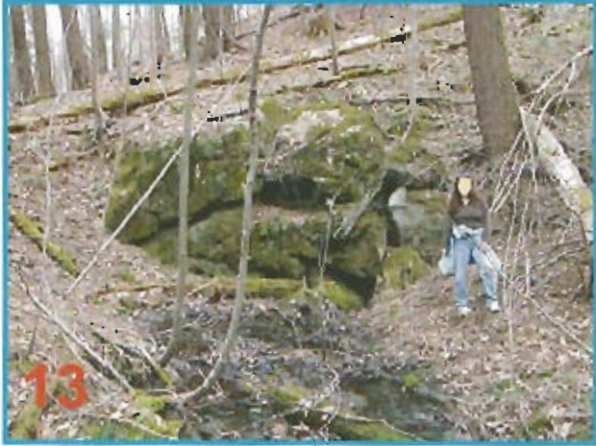
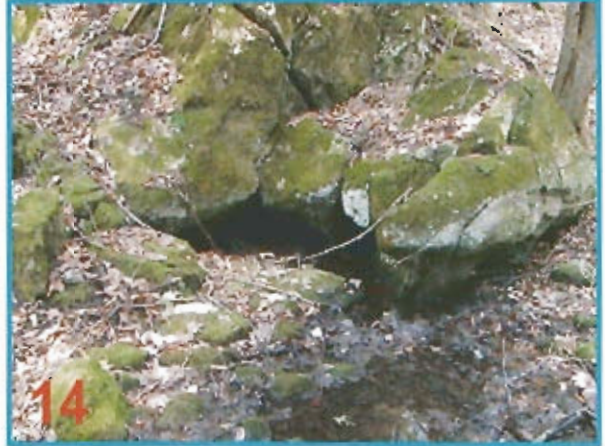
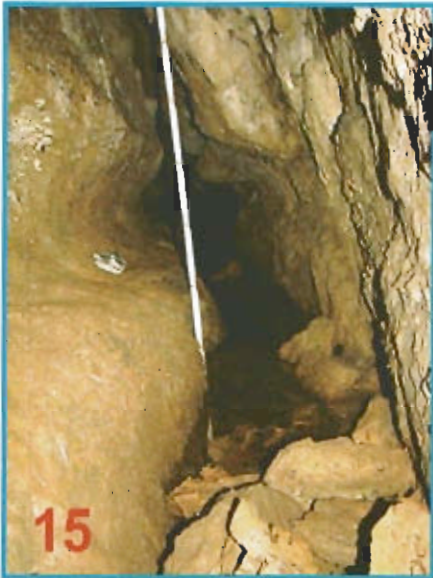
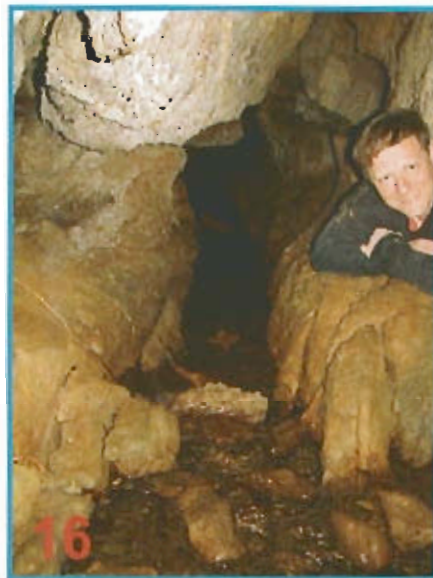
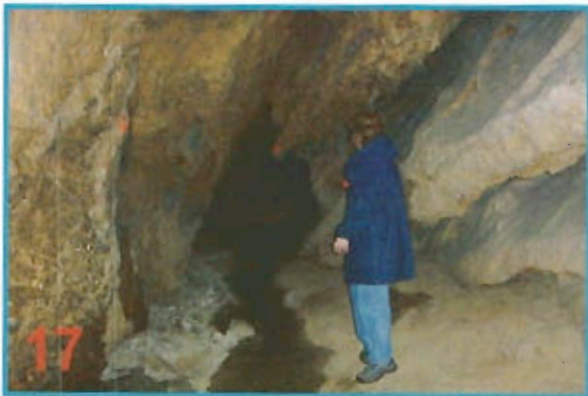
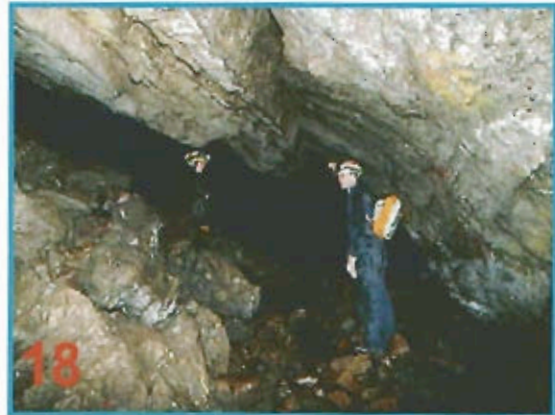
HydroQuest Photocomposite 3

- HRVR asserts that natural caves are not present on the Williams Lake property, instead concluding that "*the nature of these formations at the site due to thinner bedding, deformation, and faulting constrained the development of solution enhanced pathways and inhibited the significant growth of interconnected voids and caverns in these formations.*" Statements such as this do not hold up in the face of physical evidence. Even a few examples observed during very limited site reconnaissance point out the need for greatly expanded hydrogeologic investigation throughout the site by experienced karst hydrologists. Evidence of conduit flow through three separate karstic conduits is presented here. The first is the steady, continuous, loss of millions of gallons of water per day from Fourth Lake (discussed above). Photos 12, 13, and 14 depict two streams sinking into carbonate bedrock on HRVR property. These are classic karst features. Again, the need for hydrogeologic assessment of the site and tracer studies to determine subsurface flow paths is accented.

- HRVR asserts that caves are not present on the Williams Lake property and cannot form due to thin bedding in bedrock, deformation, and faulting. Again, this reasoning does not hold up in the face of physical evidence. Photographs 15 and 16 depict "Mossy Cave" on HRVR property. Photo 15 has a 6 foot engineer's ruler upright in it. Note the actively flowing groundwater within Mossy Cave in photo 16. The flow is non-laminar (i.e., rapid and turbulent), as is typical of karstic groundwater flow. The subsurface conduit flow from Fourth Lake is of a similar nature, except that it occurs under conduit full flow conditions.

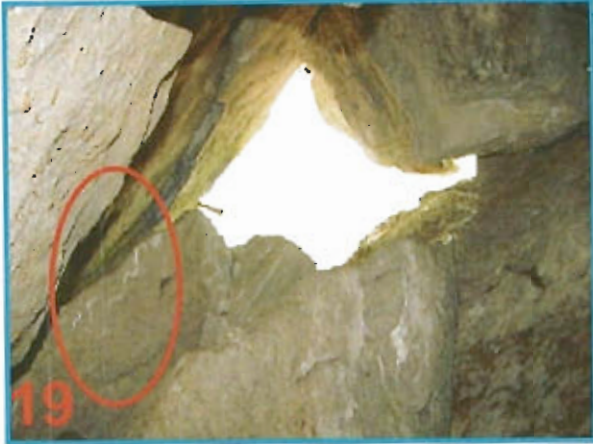
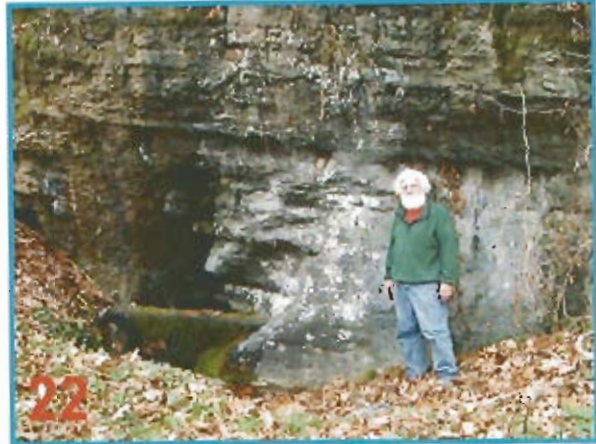
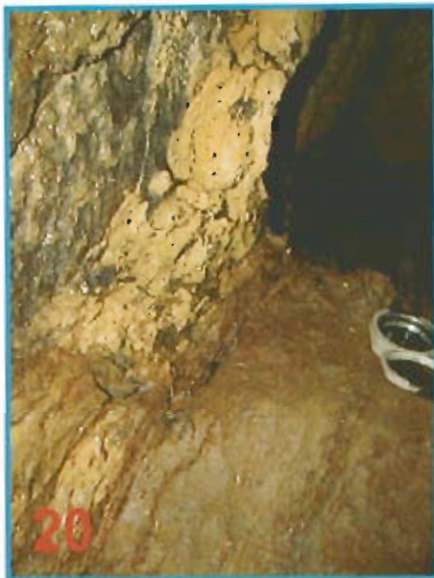
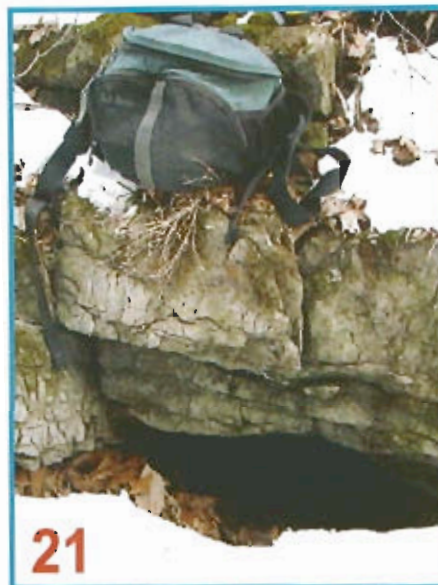
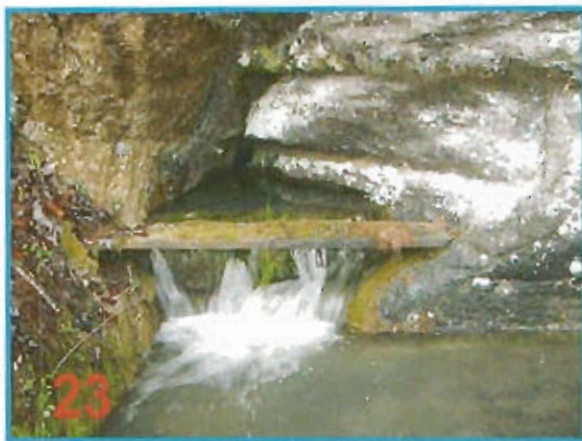
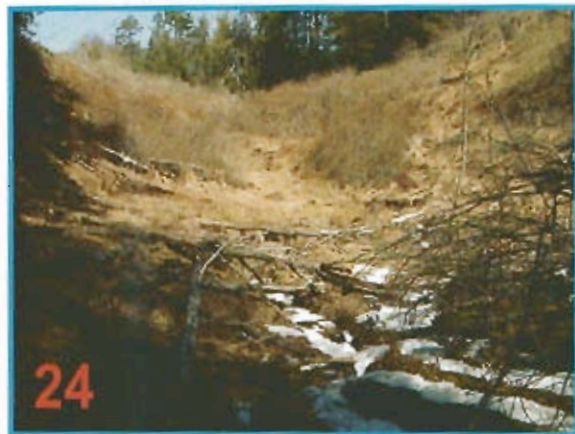
HydroQuest Photocomposite 4

- Dr. Ewers used photographs of karst features from locations not directly on HRVR property. In large part, this is because he had limited access to photographs of karst features on HRVR property. However, as an expert in karst hydrology, Dr. Ewers recognizes that karst features may be expected throughout cave-forming geologic units, often tens or hundreds of miles distant from a particular site. This is borne out by numerous sinking streams, sinkholes, springs, and caves in carbonate beds throughout the region. The local karst hydrology has

- HRVR asserts that thinly bedded carbonates impede karst formation. Photos 20 (Mossy Cave) and 21 (a cave east of HRVR property) depict cave development in thinly bedded carbonates. In fact, the best cave forming bedrock unit, the Manlius Limestone, is recognized worldwide for its extremely thin "millimeter" beds. HRVR's arguments regarding thinly bedded, folded, and deformed carbonates used to assert that the hydrogeologic setting of the Williams Lake property precludes karst development is unfounded. As such, the entire hydrogeologic study needs to be redone.
